CAN BUILDINGS BE MADE FIRE-PROOF?

By CORYDON T. PURDY, M. Am. Soc. C. E.

PRESENTED NOVEMBER 3D, 1897.

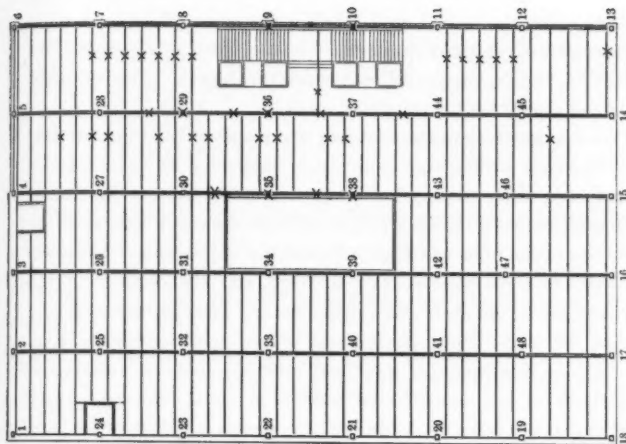
2nd FLOOR FRAMING
FIG. 3

The framework of the building was very heavy. These figures show the beams and girders which remained in place after the fire. The interior girders were 24 ins. deep, with double 22-in. web plates, 3 x 3-in. flange angles and 15-in. cover plates. The beams were all 15 ins. deep, carried on brackets riveted to the side of the box girders. These beams were not connected to the girders at all through the top flange or web, and by only two rivets through the bottom flange. The girders were fastened to the columns by two rivets in the bottom flange and two rivets in the top flange. The detail of these connections is shown in Fig. 8. The wall girders along Fifth Street were 20 ins. deep, with 3 x 6-in. flange angles and 7-in. cover plates. These girders carried the wall from floor to floor, and were completely covered by the brick masonry on the second, fifth and sixth floors. On the third and fourth floors they were, however, somewhat exposed on the inside to the action of the fire.

A careful examination of Figs. 3, 4, 5, 6 and 7, will show that more than one-third of the roof was torn away, as were large areas on all floors, decreasing from top to bottom. One cannot help asking why beams so distant from the tank were torn out by the fall. It should be particularly noticed, too, that the tank fell in a comparatively open place where the framing laterally was much weaker than elsewhere. Why, also, did the beams give way more than the girders, and why was the wall bulged out at all? It seems to the author that if the beams, girders and columns had been connected to each other, somewhat proportionately to the strength of the members themselves, the tank would have gone down through the stairs with very little injury to the structural iron work or the wall, and, at the most, this part of the loss would not have exceeded \$5 000. As it is, 16% of all the beams had to be replaced, and 14% of them had to be straightened or fixed. The use of $\frac{1}{4}$ -in. metal in the top tier of columns is also, to say

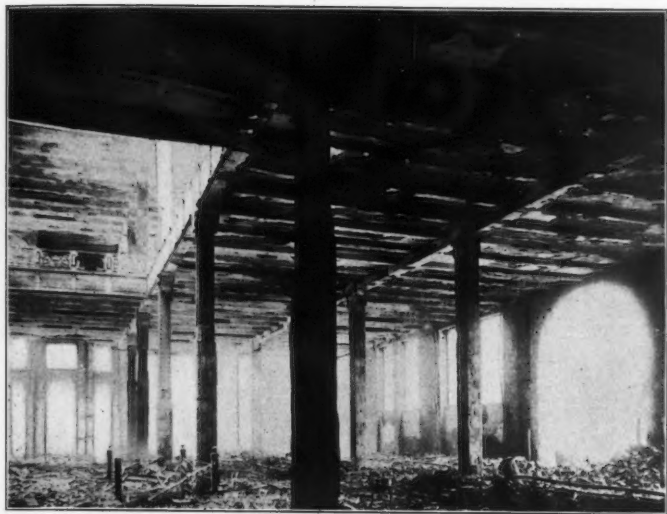
FIG. 1.

Plate III, Fig. 1, shows the condition of the Store Building after the fire, and Fig. 2 is a view on the first floor of the same building looking from the center of the building towards the fallen tank, which shows quite clearly in the background. This picture also shows the construction of the light court and the railing or balustrade which surrounded it. Plate IV, Fig. 1, is also taken on the first floor, but looking in the opposite direction. It shows the ceiling and some of the broken tile. The floor arches did not endure the fire as well on the upper floors as they did on this. Plate IV, Fig. 2, shows in the foreground how the terra cotta was flaked off and broken around the windows in the Store Building. In the background on the right it shows the ruin of the grocery store, the one-story building through which the street cars pass, and the side front of the Methodist Building. This picture was taken several weeks after the fire, and the repairs to the window frames and windows in the latter building had already been completed.

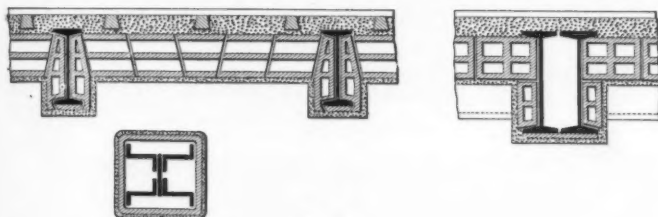
FIG. 12.

were self-supporting. The floor arches were end construction instead of side construction, and, what is most worthy of notice, they were made of porous material instead of hard-clay material. A section of the floor is shown in Fig. 12.
